**Flood Control Project Maintenance
Levee Inspections**

Fall 2018 Levee Maintenance Deficiency Summary Report

Sacramento River Basin

**Flood Control Project Maintenance
Levee Inspections****LMA District Cover Sheet
Fall 2018 Levee Inspection Results****Reclamation District No. 0349 Sutter Island**

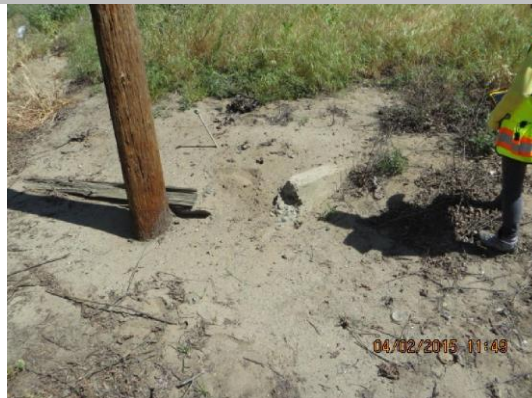
Photo 1 of 3 : UCIP_FA_2018_44303_73622.jpg

LM Start	0.08	Rating **	M	Issue No.	39 (cont)
LM End	0.08	Issue Type +	En	Location *

Deteriorated concrete distribution box on LS toe next to power pole.

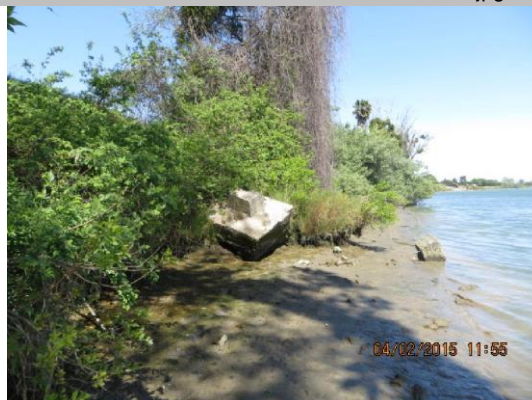
Photo 2 of 3 : UCIP_FA_2018_44303_73621.jpg

Concrete debris on WS toe is a good indicator of pump location.

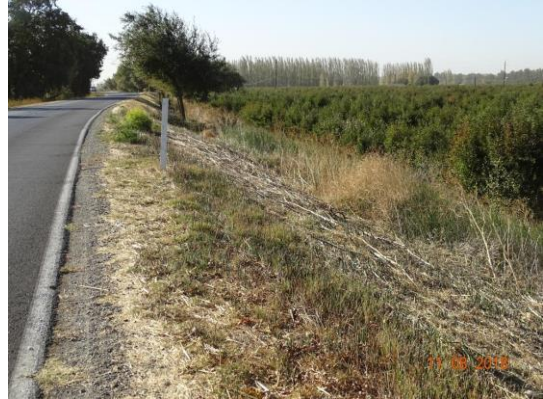
Photo 1 of 1 : FA_2018_RD0349_204_21_20181109_00029.jpg

LM Start	0.22	Rating **	M	Issue No.	21
LM End	0.26	Issue Type +	Ma	Location *	LS
Category	Earthen Levee			GPS Latitude/Longitude	
				Start	End
Item	Vegetation			38.324052 °	38.323492 °
				-121.577778 °	-121.577952 °
DWR ID	DWR_RD0349_01_f _ 2018_21				
Comment Code					
V1 : Control annual grass and weeds on the levee slopes and easements.					
Inspector Comment					
Remove vegetation all the way down to land side toe

Vegetation looking downstream on the land side slope (November 2018).

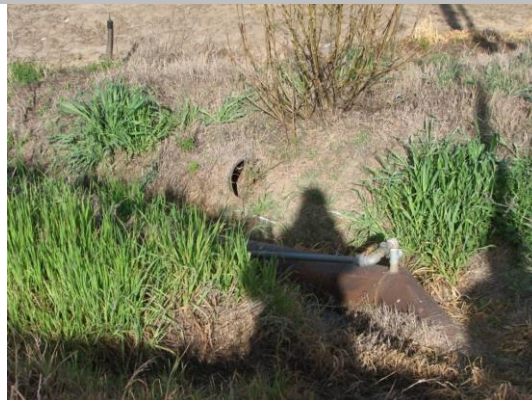
Photo 2 of 3 : UCIP_FA_2018_50062_36546.jpg

View of pipe on LS--open cut section.

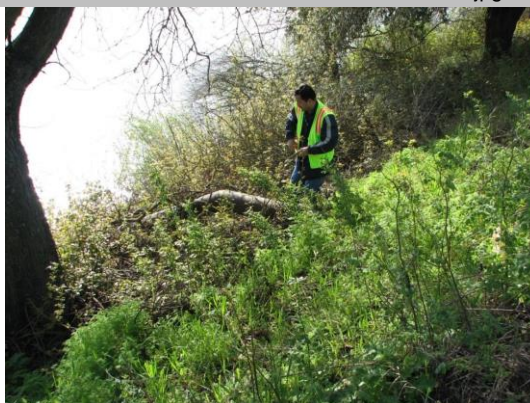
Photo 1 of 3 : UCIP_FA_2018_21572_36576.jpg

Comment Code					
Inspector Comment					
FS_ID:21572 DS_ID:24521 EP_NO: N/A Repair Type: Non-Urgent Crossing Status: Found UCIP Comments: No records were found during intial desk study--need to contact owner to obtain permit number authorizing work. If crossing is no longer used by owner, the owner will need to coordinate with DWR Inspector and CVFPB to remove crossing according to Title 23 requirements. Dense vegetation limits the inspector's visibility to identify signs of pipe failure (leaks) along the slope. Recommend removing vegetation along pipe alignment to conduct proper inspection of structure and appurtenances. Note date on photos should be 3/18/09 not 7/26/08 camera metadata is incorrect. FIELD_STRUCT_DESC: *ABANDONED* 8-inch irrigation pipe of unknown material through the levee, 13.9 feet below the levee crown. Pump on platform at landside (LS) toe. Service pole on LS slope. FS Date: 3/18/2009

View of pipe crossing located on waterward side--dense vegetation on levee slope.

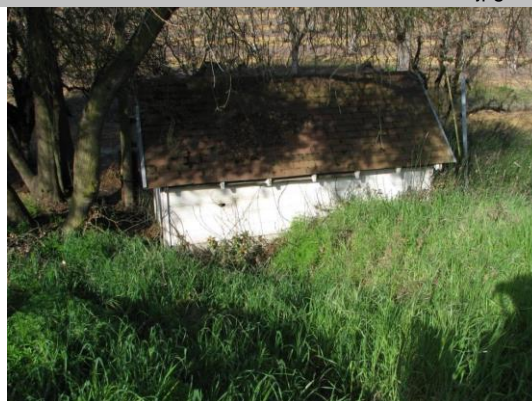
Photo 2 of 3 : UCIP_FA_2018_21572_36573.jpg

Pump house located on landward side at toe.

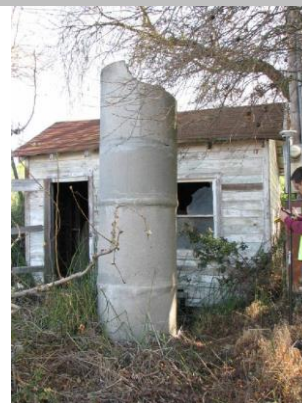
Photo 3 of 3 : UCIP_FA_2018_21572_36578.jpg

View of pump house, concrete stand pipe, and utility pole.

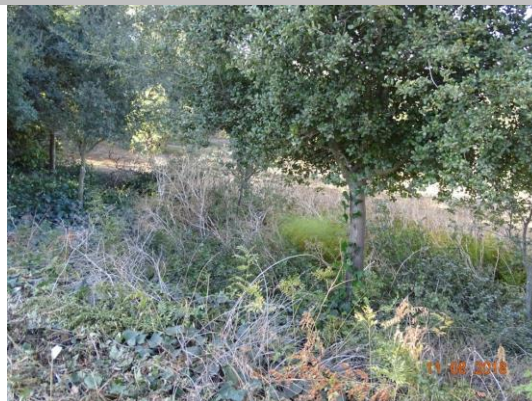
Photo 1 of 1 : FA_2018_RD0349_204_35_20181109_00030.jpg

LM Start	0.97	Rating **	U	Issue No.	35
LM End	0.97	Issue Type +	Ma	Location *	LS
Category	Earthen Levee			GPS Latitude/Longitude	
				Start	End
Item	Vegetation			38.313380 °	38.313380 °
				-121.578860 °	-121.578860 °
DWR ID	DWR_RD0349_01_f_2018_35				
Comment Code					
V2 : Remove the wild growth other than native grasses from the levee slopes.					
Inspector Comment					
Remove vegetation at land side toe

View of vegetation on the land side toe (November 2018).

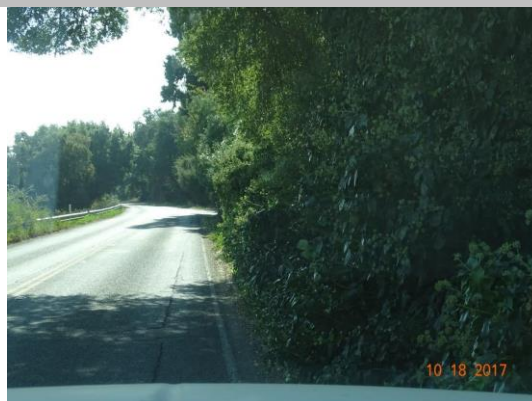
Photo 1 of 1 : FA_2018_RD0349_204_27_20180925_00006.jpg

LM Start	0.98	Rating **	U	Issue No.	27
LM End	0.98	Issue Type +	En	Location *	LS
Category	Earthen Levee			GPS Latitude/Longitude	
				Start	End
Item	Vegetation			38.313200 °	38.313200 °
				-121.578797 °	-121.578797 °
DWR ID	DWR_RD0349_01_f_2017_27				
Comment Code					
V6 : Landscaping					
Inspector Comment					
Landside landscaping must be removed or trimmed to allow inspection and access.

Landside landscaping must be removed or trimmed to allow inspection and access.

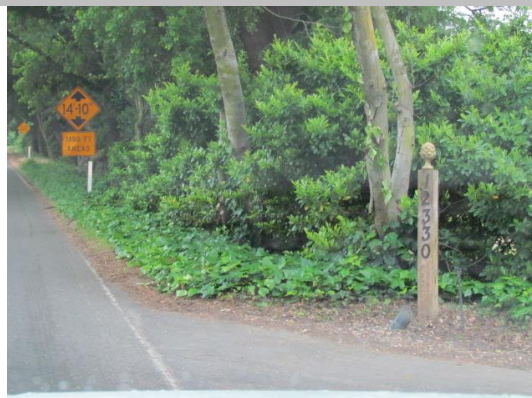
Photo 1 of 1 : FA_2018_RD0349_204_16_20180925_00004.jpg

LM Start	1.06	Rating **	U	Issue No.	16
LM End	1.10	Issue Type +	En	Location *	LS
Category	Earthen Levee			GPS Latitude/Longitude	
				Start	End
Item	Vegetation			38.311992°	38.311432°
				-121.578460°	-121.578252°
DWR ID	DWR_RD0349_01_f_2016_16				
Comment Code					
V6 : Landscaping					
Inspector Comment					
The landscaping along levee mile 1.06-1.12 is unmaintained and completely blocking the view of landside levee slope.

RF 349 Unit 1 levee mile 1.06-1.24.

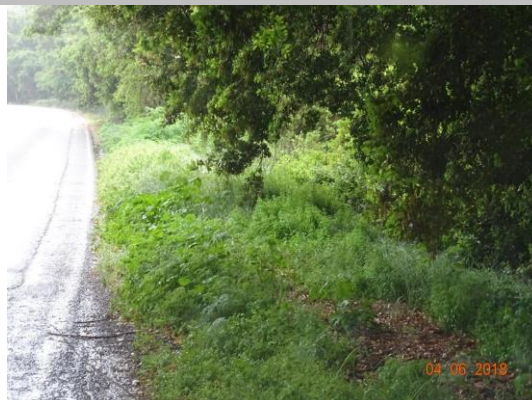
Photo 1 of 1 : FA_2018_RD0349_204_29_20180925_00007.jpg

LM Start	1.20	Rating **	U	Issue No.	29
LM End	1.21	Issue Type +	Ma	Location *	LS
Category	Earthen Levee			GPS Latitude/Longitude	
				Start	End
Item	Vegetation			38.310110 °	38.309955 °
				-121.577608 °	-121.577495 °
DWR ID	DWR_RD0349_01_f_2017_29				
Comment Code					
V2 : Remove the wild growth other than native grasses from the levee slopes.					
Inspector Comment

Manage landside vegetation to allow inspection and access.

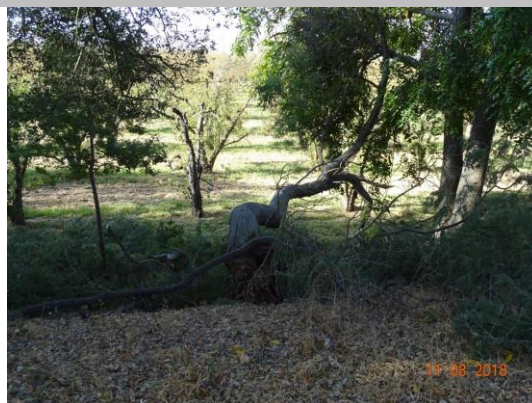
Photo 1 of 1 : FA_2018_RD0349_204_36_20181109_00031.jpg

LM Start	1.40	Rating **	M	Issue No.	36
LM End	1.40	Issue Type +	Ma	Location *	LS
Category	Earthen Levee			GPS Latitude/Longitude	
				Start	End
Item	Encroachments			38.307553 °	38.307553 °
				-121.575848 °	-121.575848 °
DWR ID	DWR_RD0349_01_f_2018_36				
Comment Code					
TR : Tree or limb					
Inspector Comment

View of fallen tree limb on the land side toe (November 2018).

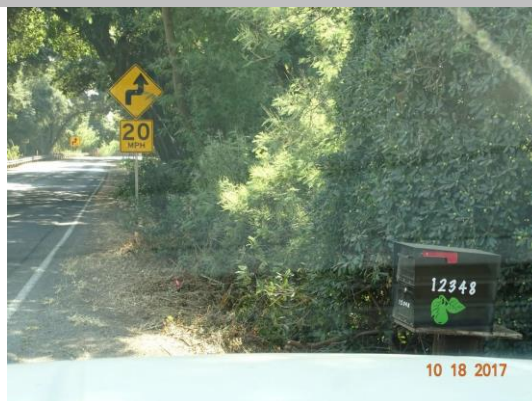
Photo 1 of 1 : FA_2018_RD0349_204_33_20180925_00008.jpg

LM Start	1.45	Rating **	M	Issue No.	33
LM End	1.45	Issue Type +	En	Location *	LS
Category	Earthen Levee			GPS Latitude/Longitude	
				Start	End
Item	Vegetation			38.306919 °	38.306919 °
				-121.575473 °	-121.575473 °
DWR ID	DWR_RD0349_01_f_2017_33				
Comment Code					
V6 : Landscaping					
Inspector Comment					
Landside landscaping should be thinned and maintained to allow inspepction and access to levee slope and toe.

Landside landscaping should be thinned and maintained to allow inspection and access to levee slope and toe.

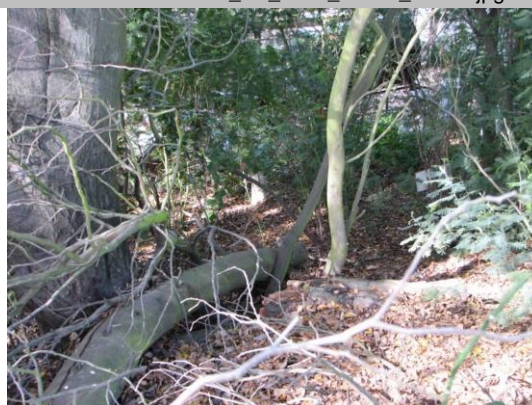
Photo 1 of 3 : UCIP_FA_2018_44214_36572.jpg

Comment Code					
Inspector Comment					
FS_ID:44214 DS_ID:24143 EP_NO: 12005 Repair Type: Non-Urgent Crossing Status: Found UCIP Comments: Pipe open on WS slope. 2007 Erosion Repair Site location?--Need to contact owner to determine if crossing is still in use. Dense vegetation limits the inspector's visibility to identify signs of pipe failure (leaks) along the slope. Recommend removing vegetation along pipe alignment to conduct proper inspection of structure and appurtenances. Note date on photos should be 3/18/09 not 7/26/08 camera metadata is incorrect. FIELD_STRUCT_DESC: 6-inch steel irrigation pipe through the levee, 4.0 feet below the levee crown. Siphon breaker and protective housing at levee shoulder. Pump located on waterside (WS). Pipe exposed on WS slope, extending to pump. Discharge structure at landside (LS) toe. (pump installed with a 6-inch pipe authorized under Permit No. 12005, 1977 - C. Van Loben Sels) [Additional Reference(s): DWR Levee Log, 2005] FS Date: 4/2/2015

View of landward side.

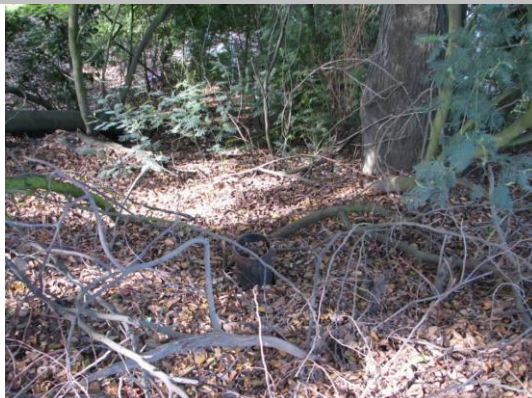
Photo 2 of 3 : UCIP_FA_2018_44214_36571.jpg

Pipe located on landward side--unable to determine whether it belongs to crossing.

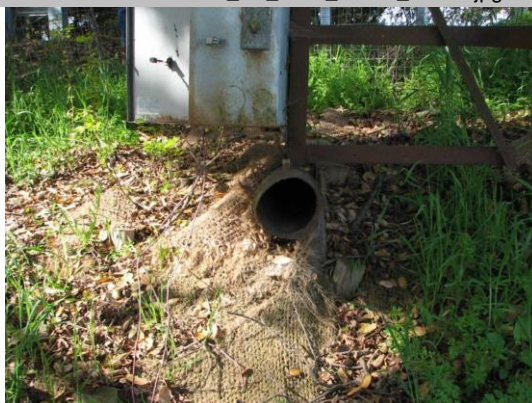
Photo 3 of 3 : UCIP_FA_2018_44214_36570.jpg

View of pipe at waterward shoulder with control box.

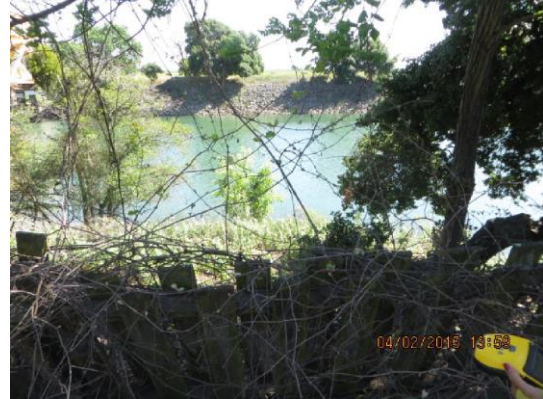
Photo 2 of 3 : UCIP_FA_2018_46169_74546.jpg

Fence on WS shoulder.

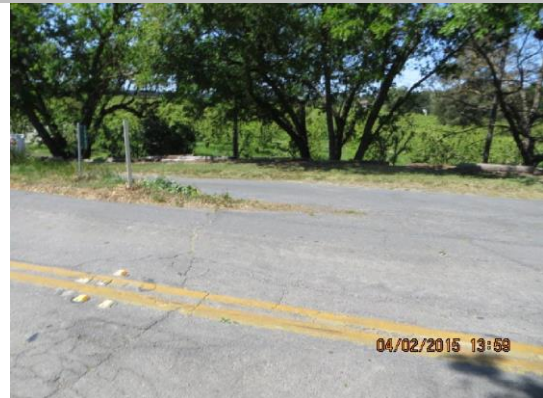
Photo 3 of 3 : UCIP_FA_2018_46169_74547.jpg

Approximate location of pipe alignment on LS of crown.

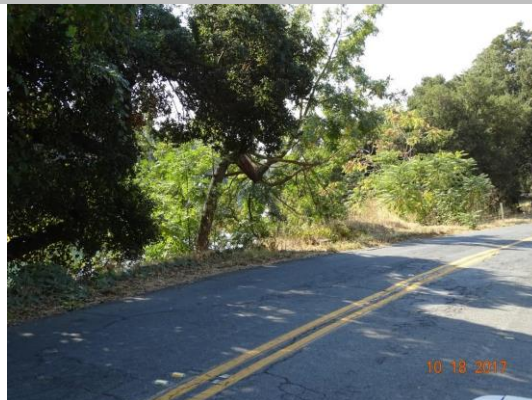
Photo 1 of 1 : FA_2018_RD0349_205_44_20180925_00029.jpg

LM Start	0.04	Rating **	M	Issue No.	44
LM End	0.08	Issue Type +	Ma	Location *	WS
Category	Earthen Levee			GPS Latitude/Longitude	
				Start	End
Item	Vegetation			38.304877 °	38.304719 °
				-121.575384 °	-121.576083 °
DWR ID	DWR_RD0349_02_f_2017_44				
Comment Code					
V2 : Remove the wild growth other than native grasses from the levee slopes.					
Inspector Comment					
Waterside vegetation should be removed or thinned to 20 feet from crown to allow inspection and access.

Waterside vegetation should be removed or thinned to 20 feet from crown to allow inspection and access.

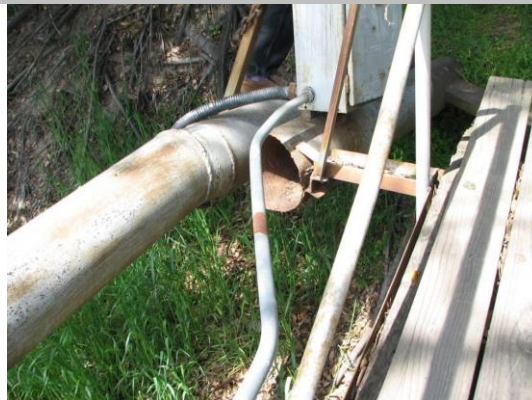
Photo 2 of 3 : UCIP_FA_2018_21576_36592.jpg

Comment Code						
Inspector Comment						
FS_ID:21576 DS_ID:24145 EP_NO: N/A Repair Type: Non-Urgent Crossing Status: Found UCIP Comments: No connection present--need to contact owner to determine if owner plans to use. If crossing is no longer in use owner will need to coordinate with DWR inspector and CVFPB to remove according to Title 23 requirements. Dense vegetation limits the inspector's visibility to identify signs of pipe failure (leaks) along the slope. Recommend removing vegetation along pipe alignment to conduct proper inspection of structure and appurtenances. Unable to determine if crossing is in use. Note date on photos should be 3/18/09 not 7/26/08 camera metadata is incorrect. FIELD_STRUCT_DESC: *ABANDONED* 10-inch irrigation pipe through the levee, 6.0 feet below the levee crown. Pump and slide gate are located on the waterside (WS) slope. Concrete pipe riser and distribution box located on the landside (LS) toe. Service pole and anchor on the LS slope. [Additional Reference(s): DWR Levee Log, 2005] FS Date: 3/18/2009

Pipes through levee at waterward slope.

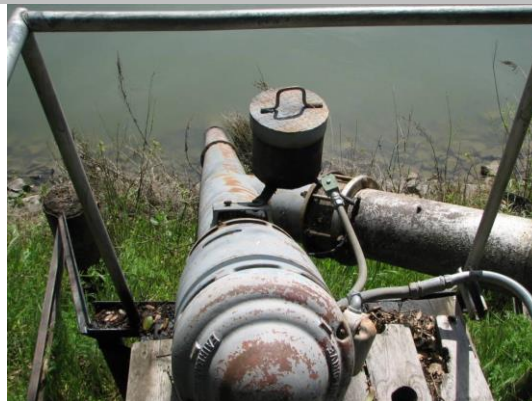
Photo 2 of 3 : UCIP_FA_2018_21577_36596.jpg

Comment Code						
Inspector Comment						
FS_ID:21577 DS_ID:24146 EP_NO: 2480 Repair Type: Non-Urgent Crossing Status: Found UCIP Comments: Dense vegetation limits the inspector's visibility to identify signs of pipe failure (leaks) along the landward slope. Recommend removing vegetation along pipe alignment to conduct proper inspection of structure and appurtenances. Unable to determine if crossing is in use. Note date on photos should be 3/18/09 not 7/26/08 camera metadata is incorrect. FIELD_STRUCT_DESC: 10-inch steel irrigation pipe through the levee, 6.0 feet below the levee crown. Pump and slide gate on the waterside (WS) slope. Concrete pipe riser and distribution box with gate valve located on the landside (LS) toe. Service pole and anchor on the LS slope. (10-inch pipe installed under Permit No. 2480, 1959 - L. C. Peck) [Additional Reference(s): DWR Levee Log, 2005] FS Date: 3/18/2009

View of waterward side--pump and raised platform.

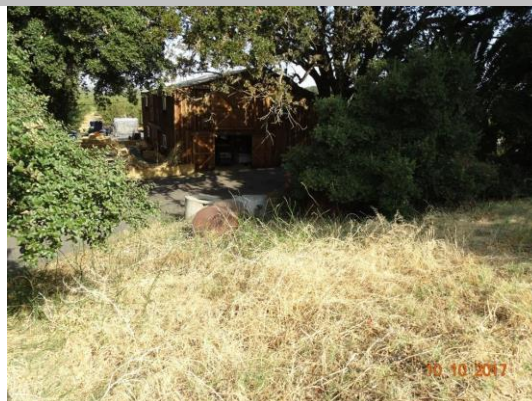
Photo 1 of 1 : FA_2018_RD0349_205_46_20180925_00030.jpg

Equipment at landside levee toe.

LM Start	0.11	Rating **	M	Issue No.	46
LM End	0.11	Issue Type +	En	Location *	LS
Category	Earthen Levee			GPS Latitude/Longitude	
				Start	End
Item	Encroachments			38.304450 °	38.304450 °
				-121.576562 °	-121.576562 °
DWR ID	DWR_RD0349_02_s_2016_46				
Comment Code					
EQ : Equipment					
Inspector Comment					
Move the equipment away from the levee toe.

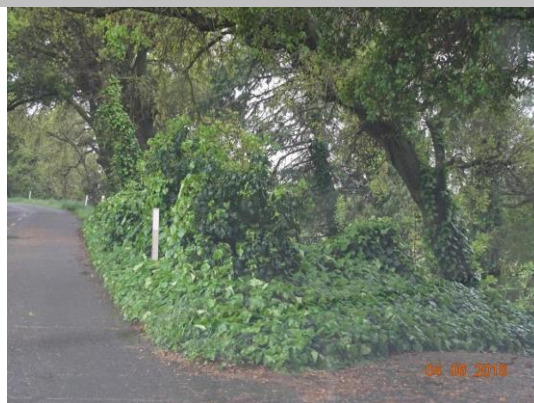
Photo 1 of 1 : FA_2018_RD0349_205_76_20180925_00043.jpg

LM Start	0.22	Rating **	U	Issue No.	76
LM End	0.22	Issue Type +	En	Location *	LS
Category	Earthen Levee			GPS Latitude/Longitude	
				Start	End
Item	Vegetation			38.303528 °	38.303528 °
				-121.578179 °	-121.578179 °
DWR ID	DWR_RD0349_02_s_2018_76				
Comment Code					
V6 : Landscaping					
Inspector Comment					
Thick ivy prevents inspection and access. Should be removed.

Landside ivy should be reduced to allow inspection and access.

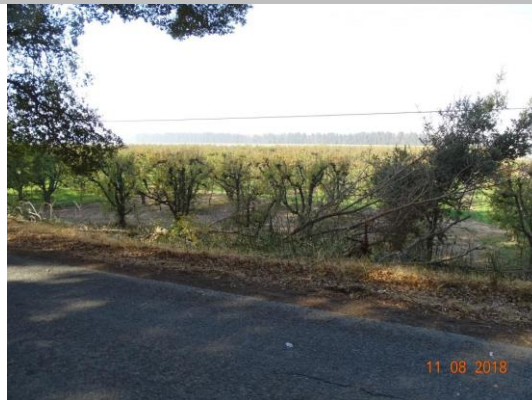
Photo 1 of 1 : FA_2018_RD0349_205_75_20181109_00109.jpg

View of down tree on the land side slope (November 2018).

LM Start	0.25	Rating **	M	Issue No.	75
LM End	0.25	Issue Type +	Ma	Location *	LS
Category	Earthen Levee			GPS Latitude/Longitude	
				Start	End
Item	Encroachments			38.303317 °	38.303317 °
				-121.578673 °	-121.578673 °
DWR ID	DWR_RD0349_02_f_2018_75				
Comment Code					
TR : Tree or limb					
Inspector Comment					
Remove down tree from the land side slope

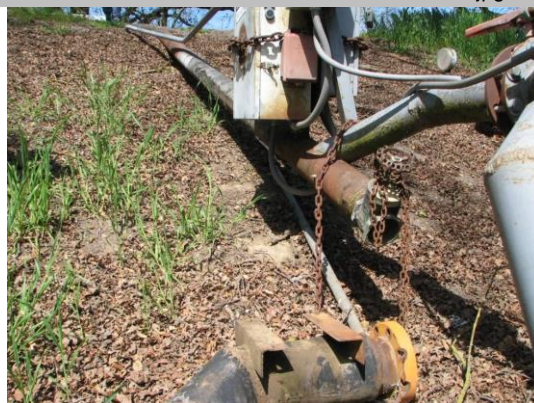
Photo 2 of 3 : UCIP_FA_2018_21614_36690.jpg

FS_ID:21614
DS_ID:24148
EP_NO: 12006
Repair Type: Non-Urgent
Crossing Status: Found
UCIP Comments: Altered crossing--contact owner to obtain new permit authoring work. Debris remains on site. Dense vegetation limits the inspector's visibility to identify signs of pipe failure (leaks) along the slope. Recommend removing vegetation along pipe alignment to conduct proper inspection of structure and appurtenances. Note date on photos should be 3/18/09 not 7/26/08 camera metadata is incorrect. FIELD_STRUCT_DESC: 6-inch steel irrigation pipe through the levee, 4 feet below the levee crown. 3-inch conduit through levee to service pump. Steel cutoff wall around pipe at center of levee. Siphon breaker in concrete riser at landside (LS) shoulder. Gate valve on LS. Pump on concrete pad on waterside (WS) slope. Discharge structure at LS toe. (pump with 6-inch pipe authorized under Permit No. 12006, 1977 - Carel Van Loben Sels) [Additional Reference(s): DWR Levee Log, 2005]

Crossing has been altered--abandoned pipe through levee slope remains.

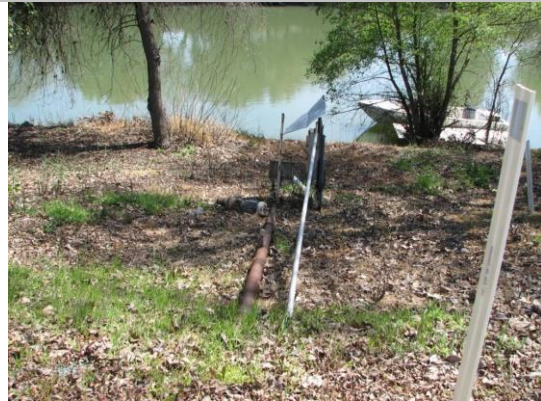
Photo 1 of 3 : UCIP_FA_2018_21615_36694.jpg

Comment Code					
Inspector Comment					
FS_ID:21615 DS_ID:24149 EP_NO: N/A Repair Type: Non-Urgent Crossing Status: Found UCIP Comments: Need to contact owner (Permit No. 3678) to determine if crossing is still in use. If crossing is not in use will need to coordinate with DWR Inspector and CVFPB to remove pipe according to Title 23 requirements. Note date on photos should be 3/18/09 not 7/26/08 camera metadata is incorrect. FIELD_STRUCT_DESC: 6-inch steel irrigation pipe through the levee, 2.5 feet below the crown. Pump on waterside (WS) slope. Service pole at landside (LS) shoulder. 3-inch conduit through levee to service pump. (removed and installed pump, and construction of cement filled steel piling foundation on levee authorized under Permit No. 3678, 1961 - Ostman Bros.) [Additional Reference(s): DWR Levee Log, 2005. USACE Sacramento O&M Manual Unit No. 110, May 1959, revised 29 Dec 2016, (HLM 0.6)] FS Date: 3/18/2009

View of pipe and pump on waterward side.

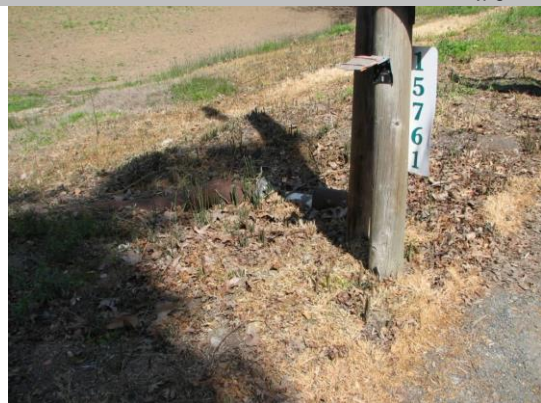
Photo 2 of 3 : UCIP_FA_2018_21615_36695.jpg

View of landard shoulder--service pole and pipe section through slope.

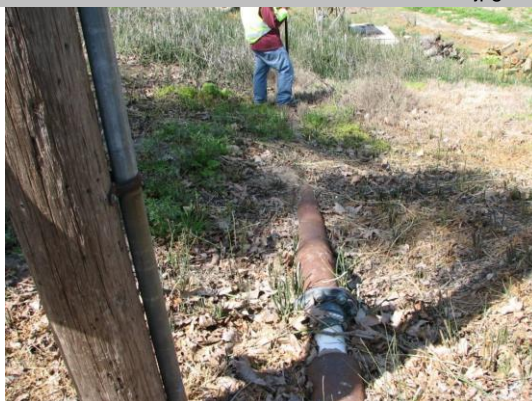
Photo 3 of 3 : UCIP_FA_2018_21615_36696.jpg

Comment Code						
Inspector Comment						
FS_ID:21615 DS_ID:24149 EP_NO: N/A Repair Type: Non-Urgent Crossing Status: Found UCIP Comments: Need to contact owner (Permit No. 3678) to determine if crossing is still in use. If crossing is not in use will need to coordinate with DWR Inspector and CVFPB to remove pipe according to Title 23 requirements. Note date on photos should be 3/18/09 not 7/26/08 camera metadata is incorrect. FIELD_STRUCT_DESC: 6-inch steel irrigation pipe through the levee, 2.5 feet below the crown. Pump on waterside (WS) slope. Service pole at landside (LS) shoulder. 3-inch conduit through levee to service pump. (removed and installed pump, and construction of cement filled steel piling foundation on levee authorized under Permit No. 3678, 1961 - Ostman Bros.) [Additional Reference(s): DWR Levee Log, 2005. USACE Sacramento O&M Manual Unit No. 110, May 1959, revised 29 Dec 2016, (HLM 0.6)] FS Date: 3/18/2009

View of landward side--it appears PVC pipe was sleeved through existing crossing.

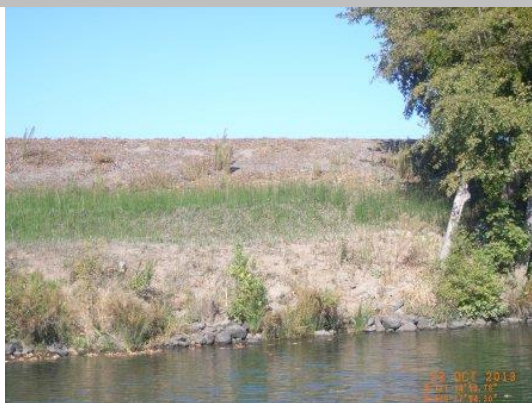
Photo 1 of 1 : FA_2018_RD0349_205_28_20181114_00110.jpg

LM Start	0.60	Rating **	M	Issue No.	28
LM End	0.72	Issue Type +	Ma	Location *	WS
Category	Supplemental			GPS Latitude/Longitude	
				Start	End
Item	2017 USACE Erosion Survey, DRAFT			38.298897 °	38.297384 °
				-121.581571 °	-121.582176 °
DWR ID	DWR_RD0349_02_f_2018_28				
Comment Code					
Inspector Comment					
2017 Site ID: STM 25.5 R					
Status: Eroding					
2017 Field Notes: No observed change.					
Site History: 2010 - Small maintenance, erosion into the toe. 2011 - Minor new erosion at toe. 2015 - Minor new erosion at toe, new tree pop-out. 2016 - Fresh scarp at downstream end.

USACE 2013 Photo #1

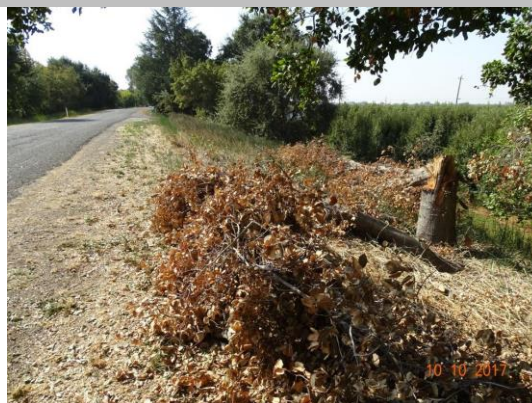
Photo 1 of 1 : FA_2018_RD0349_205_7_20180925_00006.jpg

LM Start	0.93	Rating **	M	Issue No.	7
LM End	0.93	Issue Type +	Ma	Location *	LS
Category	Earthen Levee			GPS Latitude/Longitude	
				Start	End
Item	Encroachments			38.294385 °	38.294385 °
				-121.583351 °	-121.583351 °
DWR ID	DWR_RD0349_02_f_2017_7				
Comment Code					
TR : Tree or limb					
Inspector Comment					
Fallen tree has been removed from road, but currently obstructs visibility and access to landside slope. Smaller branches/foliage are stacked along both roadway shoulders. All debris should be removed from levee.

Fallen tree on landside slope.

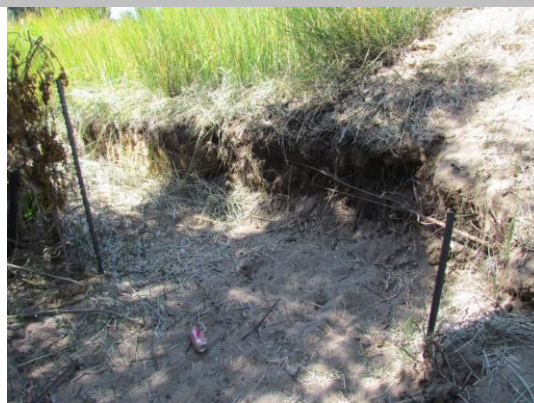
Photo 1 of 2 : FA_2018_RD0349_205_36_20180925_00013.jpg

LM Start	1.08	Rating **	U	Issue No.	36
LM End	1.08	Issue Type +	En	Location *	WS
Category	Earthen Levee			GPS Latitude/Longitude	
				Start	End
Item	Encroachments			38.292380 °	38.292282 °
				-121.583963 °	-121.583958 °
DWR ID	DWR_RD0349_02_f_2016_36				
Comment Code					
ST : Stairway					
Inspector Comment					
Land owner has excavated and installed stairs on the waterside slope. Stairs should be removed and slope restored to original configuration as soon as possible.

RD 349 Unit 2 waterside slope and berm Land owner has dug a pit.

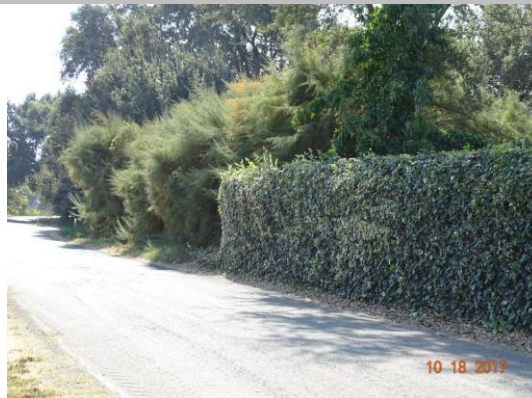
Photo 1 of 1 : FA_2018_RD0349_205_57_20180925_00034.jpg

LM Start	1.33	Rating **	U	Issue No.	57
LM End	1.33	Issue Type +	En	Location *	LS
Category	Earthen Levee			GPS Latitude/Longitude	
				Start	End
Item	Vegetation			38.288742 °	38.288742 °
				-121.583980 °	-121.583980 °
DWR ID	DWR_RD0349_02_f_2017_57				
Comment Code					
V6 : Landscaping					
Inspector Comment					
Landside landscaping should be thinned and maintained to allow inspection and access to levee slope and toe.

Landside landscaping should be thinned and maintained to allow inspection and access to levee slope and toe.

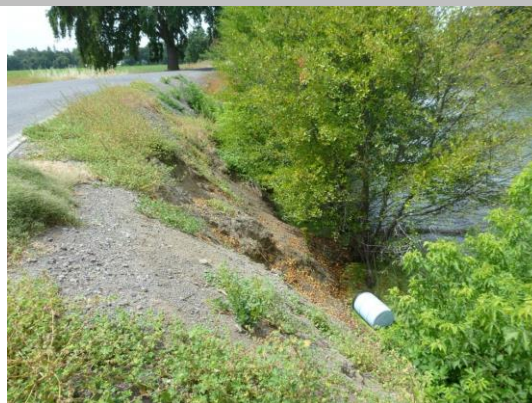
Photo 1 of 3 : FA_2018_RD0349_205_40_20180925_00018.jpg

LM Start	1.33	Rating **	M	Issue No.	40
LM End	1.49	Issue Type +	Ma	Location *	
Category	Supplemental			GPS Latitude/Longitude	
				Start	End
Item	2017 Storm Damage			38.288727 °	38.286475 °
				-121.583823 °	-121.585026 °
DWR ID	DWR_RD0349_02_f_2017_40				
Comment Code					
Inspector Comment					
Levee Evaluation Comments					
Description:					
Site ID No:66					
Site Designation:DWR_RD0349_02_s_2012_28					
Repair Type: Erosion					
Rating:Area of Concern					
Field Date:6/7/2017					
Notes: dense vegetation and large trees hindered visibility; slope riprap appeared failing in some parts

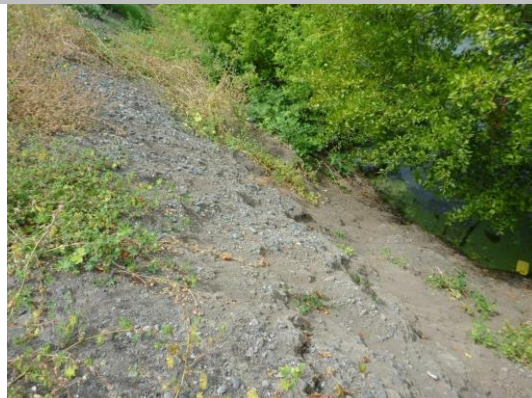
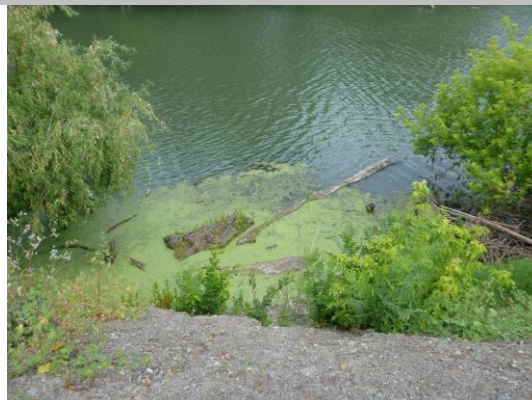
LM Start	1.33	Rating **	M	Issue No.	40 (cont)	
LM End	1.49	Issue Type +	Ma	Location *		
Category	Supplemental			GPS Latitude/Longitude		
				Start	End	
Item	2017 Storm Damage			38.288727°	38.286475°	
				-121.583823°	-121.585026°	
DWR ID	DWR_RD0349_02_f_2017_40					
Comment Code						
Inspector Comment						
Levee Evaluation Comments						
Description:						
Site ID No:66						
Site Designation:DWR_RD0349_02_s_2012_28						
Repair Type: Erosion						
Rating:Area of Concern						
Field Date:6/7/2017						
Notes: dense vegetation and large trees hindered visibility; slope riprap appeared failing in some parts

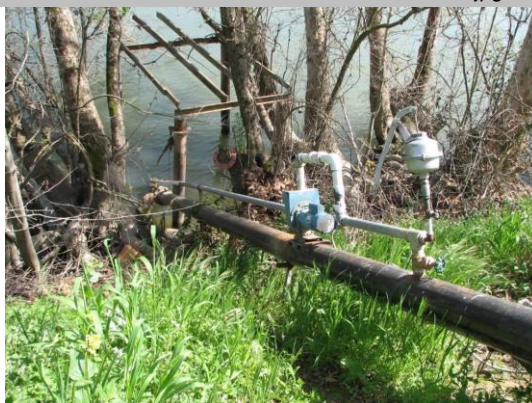
Photo 1 of 3 : UCIP_FA_2018_21606_36655.jpg

Comment Code						
Inspector Comment						
FS_ID:21606						
DS_ID:24154						
EP_NO: 6274						
Repair Type: Non-Urgent						
Crossing Status: Found						
UCIP Comments: Crossing appears to have been altered--recommend coordinating with owner to determine records for crossing. Will need permit issued for pipe install. Dense vegetation limits the inspector's visibility to identify signs of pipe failure (leaks) along the slope. Recommend removing vegetation along pipe alignment to conduct proper inspection of structure and appurtenances. Note date on photos should be 3/18/09 not 7/26/08 camera metadata is incorrect.						
FIELD_STRUCT_DESC: 12-inch steel irrigation pipe through the levee, 3 feet below the crown. Cutoff wall around pipe at waterside (WS) shoulder. Siphon breaker at landside (LS) shoulder. Air vent and pressure breaker on WS slope. Slant pump on the WS slope. Concrete distribution box at LS toe. (12-inch pipe and slant mounted pump installed and existing 8-inch pipe removed under Permit No. 6274, 1974 - P. L. Peck) [Additional Reference(s): DWR Levee Log, 2005]

View of abandoned framing located on river's edge.

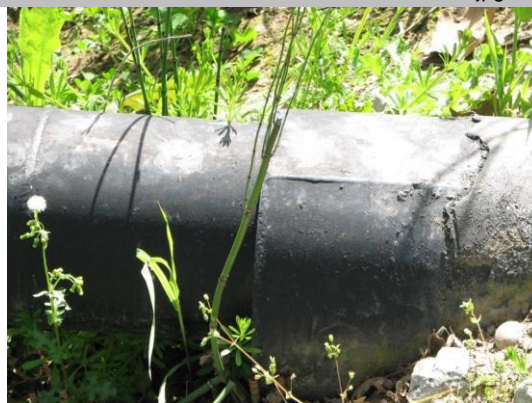
Photo 3 of 3 : UCIP_FA_2018_21606_36657.jpg

Comment Code						
Inspector Comment						
FS_ID:21606 DS_ID:24154 EP_NO: 6274 Repair Type: Non-Urgent Crossing Status: Found UCIP Comments: Crossing appears to have been altered--recommend coordinating with owner to determine records for crossing. Will need permit issued for pipe install. Dense vegetation limits the inspector's visibility to identify signs of pipe failure (leaks) along the slope. Recommend removing vegetation along pipe alignment to conduct proper inspection of structure and appurtenances. Note date on photos should be 3/18/09 not 7/26/08 camera metadata is incorrect. FIELD_STRUCT_DESC: 12-inch steel irrigation pipe through the levee, 3 feet below the crown. Cutoff wall around pipe at waterside (WS) shoulder. Siphon breaker at landside (LS) shoulder. Air vent and pressure breaker on WS slope. Slant pump on the WS slope. Concrete distribution box at LS toe. (12-inch pipe and slant mounted pump installed and existing 8-inch pipe removed under Permit No. 6274, 1974 - P. L. Peck) [Additional Reference(s): DWR Levee Log, 2005] FS Date: 3/18/2009

Pipe sleeved through larger pipe.

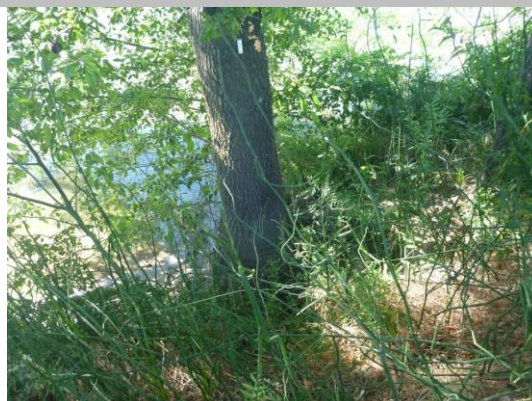
Photo 1 of 3 : FA_2018_RD0349_205_34_20180925_00010.jpg

LM Start	1.46	Rating **	A/W	Issue No.	34
LM End	1.46	Issue Type +	Ma	Location *	
Category	Supplemental			GPS Latitude/Longitude	
				Start	End
Item	2017 Storm Damage			38.286886 °	38.286861 °
				-121.584589 °	-121.584622 °
DWR ID	DWR_RD0349_02_f_2017_34				
Comment Code					
Inspector Comment					
Levee Evaluation Comments					
Description:District Station 77+56 to 77+68, Sec. 18, T. 5 N. R. 4 E., M.D.M. Approximately 12 linear feet of erosion/sloughing exists along the water side slope of Steamboat Slough (Unit 2). The erosion area commences approximately halfway down the slope from the levee crown and extends to the waterside toe around existing trees. No rip rap is visible in this area.					
Site ID No:322					
Site Designation:LMA-149					
Repair Type: Erosion					
Rating:Area of Concern					
Field Date:7/28/2017					
Notes: no berm

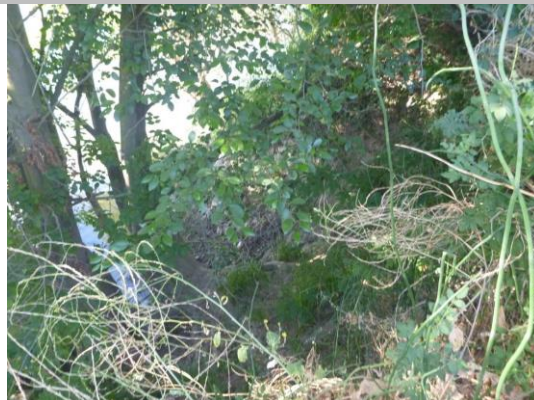
Photo 2 of 2 : FA_2018_RD0349_205_37_20180925_00016.jpg

LM Start	1.48	Rating **	A/W	Issue No.	37 (cont)
LM End	1.49	Issue Type +	Ma	Location *	
Category	Supplemental			GPS Latitude/Longitude	
				Start	End
Item	2017 Storm Damage			38.286708 °	38.286569 °
				-121.584839 °	-121.585042 °
DWR ID	DWR_RD0349_02_f_2017_37				
Comment Code					
Inspector Comment					
Levee Evaluation Comments					
Description:District Station 78+51 to 79+28, Sec. 18, T. 5 N. R. 4 E., M.D.M. Approximately 77 linear feet of erosion and scour exist along the water side slope of Steamboat Slough (Unit 2). The erosion area commences approximately halfway down the slope from the levee crown and extends to the waterside toe around existing trees. No rip rap is visible in this area.					
Site ID No:323					
Site Designation:LMA-150					
Repair Type: Erosion					
Rating:Area of Concern					
Field Date:7/28/2017					
Notes: no berm

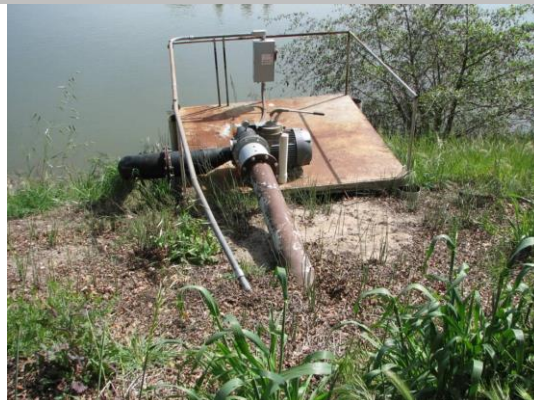
Photo 1 of 3 : UCIP_FA_2018_21607_36661.jpg

Comment Code						
Inspector Comment						
FS_ID:21607 DS_ID:24155 EP_NO: 1116 Repair Type: Non-Urgent Crossing Status: Found UCIP Comments: Dense vegetation limits the inspector's visibility to identify signs of pipe failure (leaks) along the landward slope. Recommend removing vegetation along pipe alignment to conduct proper inspection of structure and appurtenances. Note date on photos should be 3/18/09 not 7/26/08 camera metadata is incorrect. FIELD_STRUCT_DESC: 8-inch steel irrigation pipe through the levee, 4.7 feet below the levee crown. Two concrete cutoff walls under each shoulder. Pressure breaker in concrete riser at levee shoulder. Pump on waterside (WS). (8-inch pipe atuhorized under Permit No. 1116, 1974 - A. C. Ostman). [Additional Reference(s): DWR Levee Log, 2005. USACE Sacramento O&M Manual Unit No. 110, May 1959, revised 29 Dec 2016, (HLM 1.7)] FS Date: 3/18/2009

View of waterward side.

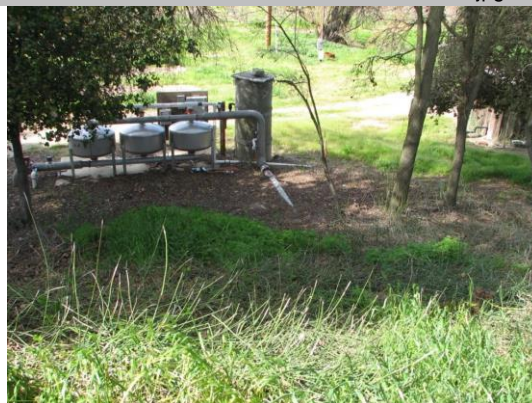
Photo 3 of 3 : UCIP_FA_2018_21607_36658.jpg

Comment Code						
Inspector Comment						
FS_ID:21607 DS_ID:24155 EP_NO: 1116 Repair Type: Non-Urgent Crossing Status: Found UCIP Comments: Dense vegetation limits the inspector's visibility to identify signs of pipe failure (leaks) along the landward slope. Recommend removing vegetation along pipe alignment to conduct proper inspection of structure and appurtenances. Note date on photos should be 3/18/09 not 7/26/08 camera metadata is incorrect. FIELD_STRUCT_DESC: 8-inch steel irrigation pipe through the levee, 4.7 feet below the levee crown. Two concrete cutoff walls under each shoulder. Pressure breaker in concrete riser at levee shoulder. Pump on waterside (WS). (8-inch pipe atuhorized under Permit No. 1116, 1974 - A. C. Ostman). [Additional Reference(s): DWR Levee Log, 2005. USACE Sacramento O&M Manual Unit No. 110, May 1959, revised 29 Dec 2016, (HLM 1.7)] FS Date: 3/18/2009

Filter system, control panel, and stand pipe located at the landward toe.

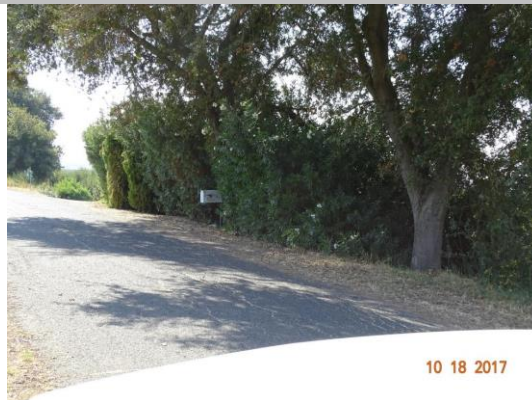
Photo 1 of 1 : FA_2018_RD0349_205_58_20180925_00035.jpg

LM Start	1.80	Rating **	M	Issue No.	58
LM End	1.80	Issue Type +	En	Location *	LS
Category	Earthen Levee			GPS Latitude/Longitude	
				Start	End
Item	Vegetation			38.283642 °	38.283642 °
				-121.589158 °	-121.589158 °
DWR ID	DWR_RD0349_02_f_2017_58				
Comment Code					
V6 : Landscaping					
Inspector Comment					
Landside landscaping should be thinned and maintained to allow inspection and access to levee slope and toe.

Landside landscaping should be thinned and maintained to allow inspection and access to levee slope and toe.

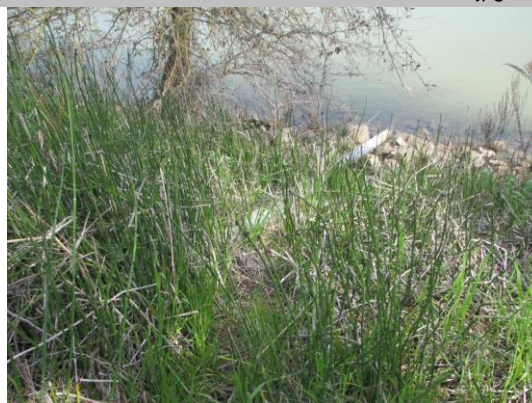
Photo 1 of 3 : UCIP_FA_2018_21608_36662.jpg

Comment Code						
Inspector Comment						
FS_ID:21608 DS_ID:24156 EP_NO: N/A Repair Type: Non-Urgent Crossing Status: Found UCIP Comments: Dense vegetation limits the inspector's visibility to identify signs of pipe failure (leaks) along the slope. Recommend removing vegetation along pipe alignment to conduct proper inspection of structure and appurtenances. Note date on photos should be 3/18/09 not 7/26/08 camera metadata is incorrect. FIELD_STRUCT_DESC: 10-inch steel irrigation pipe through the levee, 3.9 feet below the levee crown. Siphon breaker in concrete riser on the landside (LS) shoulder. Pump and gate valve in pump house on the waterside (WS) slope. [Additional Reference(s): DWR Levee Log, 2005. USACE Sacramento O&M Manual Unit No. 110, May 1959, revised 29 Dec 2016, (HLM 1.9)] FS Date: 3/18/2009

View of pipe on waterward slope.

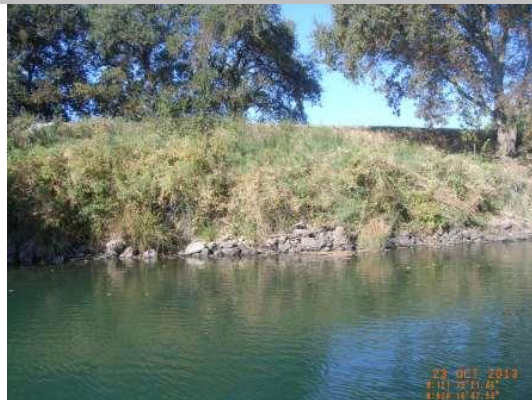
Photo 1 of 1 : FA_2018_RD0349_205_26_20181114_00038.jpg

LM Start	2.04	Rating **	M	Issue No.	26
LM End	2.05	Issue Type +	Ma	Location *	WS
Category	Supplemental			GPS Latitude/Longitude	
				Start	End
Item	2017 USACE Erosion Survey, DRAFT			38.280069 °	38.279919 °
				-121.589443 °	-121.589438 °
DWR ID	DWR_RD0349_02_f_2018_26				
Comment Code					
Inspector Comment					
2017 Site ID: STM 24.1 R					
Status: Eroding					
2017 Field Notes: No observed change.					
Site History: 2011 - Small scallop caused by erosion and wave wash.

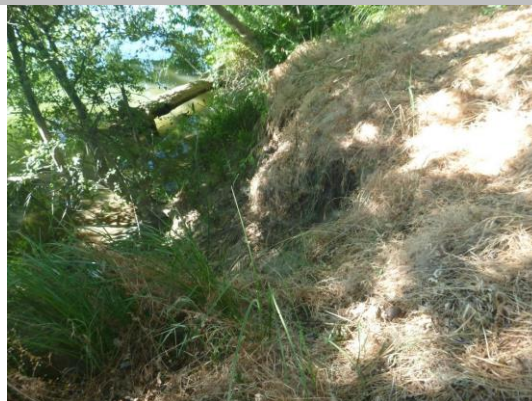
Photo 1 of 3 : FA_2018_RD0349_205_41_20180925_00021.jpg

LM Start	2.11	Rating **	A/W	Issue No.	41
LM End	2.13	Issue Type +	Ma	Location *	
Category	Supplemental			GPS Latitude/Longitude	
				Start	End
Item	2017 Storm Damage			38.279039 °	38.278806 °
				-121.589664 °	-121.589783 °
DWR ID	DWR_RD0349_02_f _ 2017_41				
Comment Code					
Inspector Comment					
Levee Evaluation Comments					
Description:District Station 112+11 to 113+04, Sec. 13, T. 5 N. R. 3 E., M.D.M. Approximately 93 linear feet of erosion exists along the water side slope of Steamboat Slough (Unit 2). The erosion area commences approximately 3/4 of the way down the slope from the levee crown and extends to the waterside toe around existing trees. No rip rap is visible in this area.					
Site ID No:324					
Site Designation:LMA-151					
Repair Type: Erosion					
Rating:Serious					
Field Date:7/28/2017					
Notes: no berm

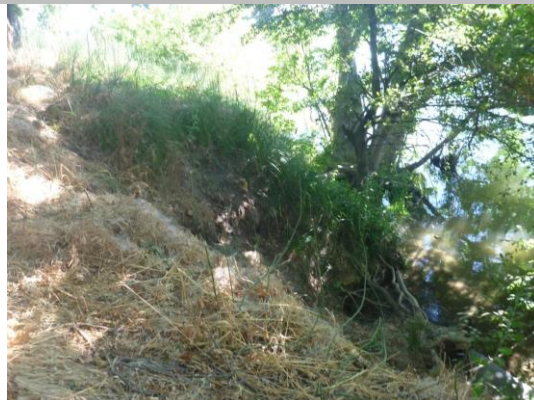
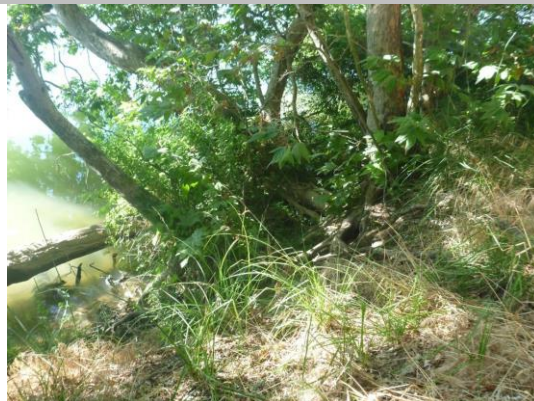
LM Start	2.11	Rating **	A/W	Issue No.	41 (cont)
LM End	2.13	Issue Type +	Ma	Location *	
Category	Supplemental			GPS Latitude/Longitude	
				Start	End
Item	2017 Storm Damage			38.279039 °	38.278806 °
				-121.589664 °	-121.589783 °
DWR ID	DWR_RD0349_02_f_2017_41				
Comment Code					
Inspector Comment					
Levee Evaluation Comments					
Description:District Station 112+11 to 113+04, Sec. 13, T. 5 N. R. 3 E., M.D.M. Approximately 93 linear feet of erosion exists along the water side slope of Steamboat Slough (Unit 2). The erosion area commences approximately 3/4 of the way down the slope from the levee crown and extends to the waterside toe around existing trees. No rip rap is visible in this area.					
Site ID No:324					
Site Designation:LMA-151					
Repair Type: Erosion					
Rating:Serious					
Field Date:7/28/2017					
Notes: no berm

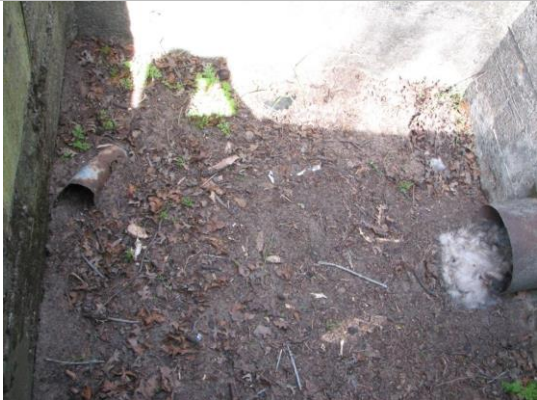
Photo 1 of 3 : UCIP_FA_2018_21609_36668.jpg

Inside view of distribution box located on landward side.

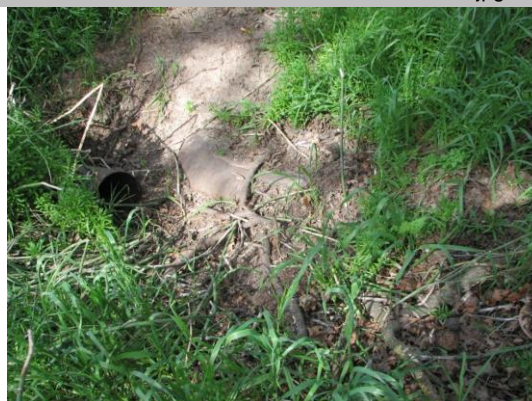
Photo 2 of 3 : UCIP_FA_2018_21609_36667.jpg

Comment Code						
Inspector Comment						
FS_ID:21609 DS_ID:24157 EP_NO: N/A Repair Type: Non-Urgent Crossing Status: Found UCIP Comments: Debris scattered--need to contact owner. If crossing is not in used will need to coordinate with DWR Inspector and CVFPB to remove per Title 23 requirements. Dense vegetation limits the inspector's visibility to identify signs of pipe failure (leaks) along the slope. Recommend removing vegetation along pipe alignment to conduct proper inspection of structure and appurtenances. Note date on photos should be 3/18/09 not 7/26/08 camera metadata is incorrect. FIELD_STRUCT_DESC: 8-inch irrigation pipe of unknown material sleeved through 12-inch pipe through the levee, 4 feet below the levee crown. Annular gap not grouted. Service pole on the waterside (WS) shoulder. Pump on the WS. Concrete distribution box at landside (LS) toe. [Additional Reference(s): DWR Levee Log, 2005. USACE Sacramento O&M Manual Unit No. 110, May 1959, revised 29 Dec 2016, (HLM 2.3), 12-inch] FS Date: 3/18/2009

Debris along pipe alignment.

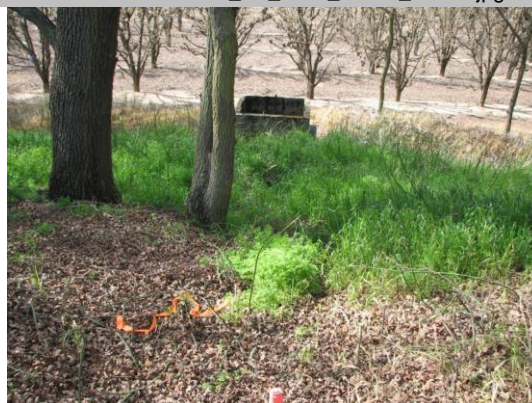
Photo 3 of 3 : UCIP_FA_2018_21609_36666.jpg

Overview of landward side--distribution box located at toe.

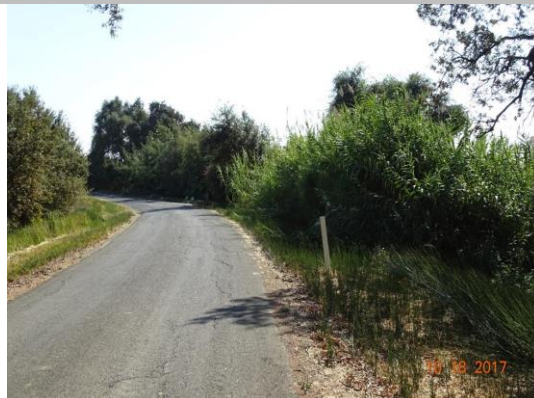
Photo 1 of 1 : FA_2018_RD0349_205_60_20180925_00037.jpg

LM Start	2.37	Rating **	U	Issue No.	60
LM End	2.44	Issue Type +	En	Location *	LS
Category	Earthen Levee			GPS Latitude/Longitude	
				Start	End
Item	Vegetation			38.275713 °	38.274919 °
				-121.591369 °	-121.590622 °
DWR ID	DWR_RD0349_02_f_2017_60				
Comment Code					
V6 : Landscaping					
Inspector Comment					
Arundo and other landscape vegetation blocks visibility and access in most areas. Arondo should be removed; the rest should be thinned.

Arundo and other vegetation blocks visibility and access in most areas.
Arundo should be removed; the rest should be thinned.

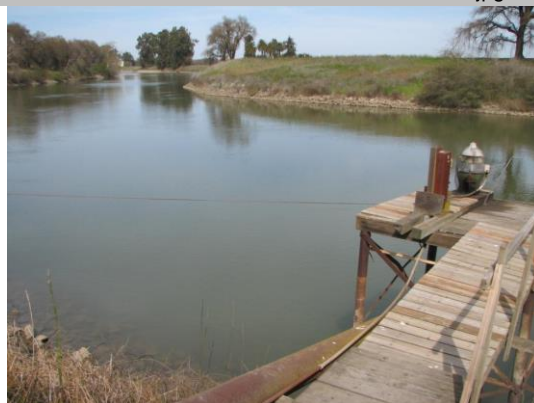
Photo 1 of 3 : UCIP_FA_2018_39873_36678.jpg

Comment Code					
Inspector Comment					
FS_ID:39873 DS_ID:24158 EP_NO: N/A Repair Type: Non-Urgent Crossing Status: Found UCIP Comments: Dense vegetation limit the inspector's visibility to identify signs of pipe failure (leaks) through the levee slopes. Recommend removing vegetation along pipe alignment to conduct proper inspection of structure and appurtenances. FIELD_STRUCT_DESC: 12-inch steel irrigation pipe through the levee, 4 feet below the levee crown. Pump on pile structure on waterside (WS), walkway to pump. Concrete distribution box and power pole with anchor at landside (LS) toe. Concrete standpipe on LS. (12-inch pipe authorized under Permit No. 946, 1944 - F. J. Mcquaid). [Additional Reference(s): DWR Levee Log, 2005. USACE Sacramento O&M Manual Unit No. 110, May 1959, revised 29 Dec 2016, (HLM 2.5)] FS Date: 3/18/2009

View of waterward side--pump and control panel located on raised platform.

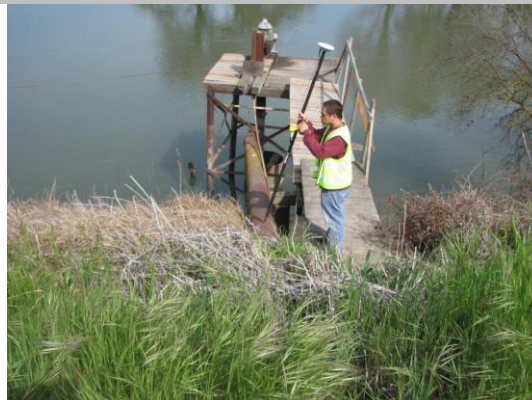
Photo 2 of 3 : UCIP_FA_2018_39873_36676.jpg

Comment Code						
Inspector Comment						
FS_ID:39873 DS_ID:24158 EP_NO: N/A Repair Type: Non-Urgent Crossing Status: Found UCIP Comments: Dense vegetation limit the inspector's visibility to identify signs of pipe failure (leaks) through the levee slopes. Recommend removing vegetation along pipe alignment to conduct proper inspection of structure and appurtenances. FIELD_STRUCT_DESC: 12-inch steel irrigation pipe through the levee, 4 feet below the levee crown. Pump on pile structure on waterside (WS), walkway to pump. Concrete distribution box and power pole with anchor at landside (LS) toe. Concrete standpipe on LS. (12-inch pipe authorized under Permit No. 946, 1944 - F. J. Mcquaid). [Additional Reference(s): DWR Levee Log, 2005. USACE Sacramento O&M Manual Unit No. 110, May 1959, revised 29 Dec 2016, (HLM 2.5)] FS Date: 3/18/2009

Overview of waterward side--dense vegetation limits slope inspection.

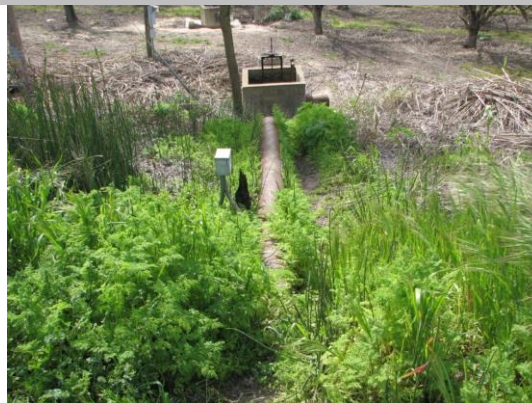
Photo 3 of 3 : UCIP_FA_2018_39873_36673.jpg

View of landward side--2 distribution boxes are located along pipe alignment.

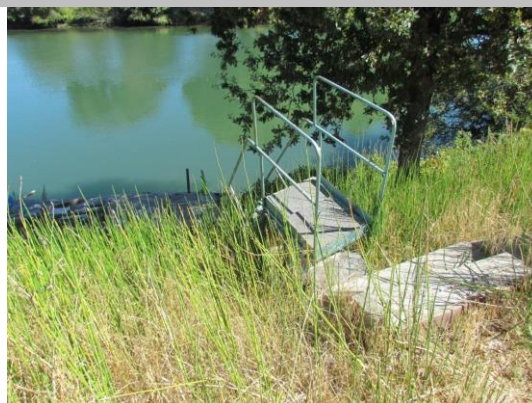
Photo 1 of 3 : FA_2018_RD0349_205_1_20180925_00001.jpg

LM Start	2.39	Rating **	U	Issue No.	1
LM End	2.39	Issue Type +	En	Location *	WS
Category	Earthen Levee			GPS Latitude/Longitude	
				Start	End
Item	Encroachments			38.275403°	38.275403°
				-121.591229°	-121.591229°
DWR ID	DWR_RD0349_02_f_2013_1				
Comment Code					
ST : Stairway					
Inspector Comment					
The landowner has installed steps on the waterside slope and has an unauthorized boat dock anchored to the waterside slope.

Unauthorized metal steps on the waterside levee slope at levee mile 2.39.

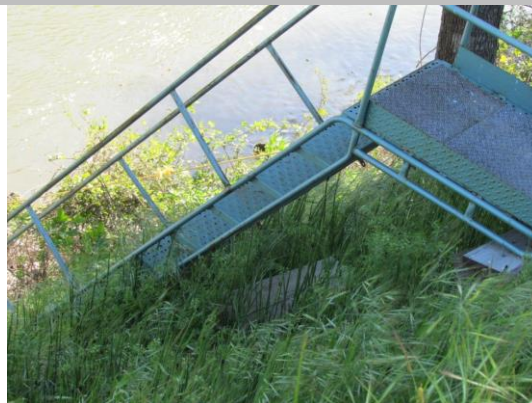
Photo 2 of 3 : FA_2018_RD0349_205_1_20180925_00002.jpg

Unauthorized metal steps on the waterside slope levee mile 2.39.

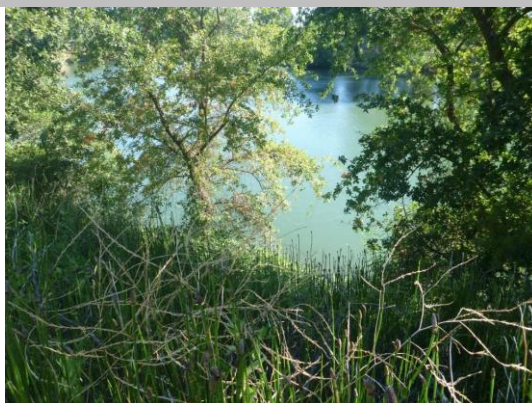
Photo 1 of 2 : FA_2018_RD0349_205_42_20180925_00024.jpg

LM Start	2.43	Rating **	A/W	Issue No.	42
LM End	2.44	Issue Type +	Ma	Location *	
Category	Supplemental			GPS Latitude/Longitude	
				Start	End
Item	2017 Storm Damage			38.275131 °	38.275036 °
				-121.590594 °	-121.590461 °
DWR ID	DWR_RD0349_02_f _ 2017_42				
Comment Code					
Inspector Comment					
Levee Evaluation Comments					
Description:District Station 128+76 to 129+27, Sec. 13, T. 5 N. R. 3 E., M.D.M. Approximately 51 linear feet of erosion exists along the water side slope of Steamboat Slough (Unit 2). The erosion area commences approximately 3/4 of the way down the slope from the levee crown and extends to the waterside toe around existing trees. No rip rap is visible in this area.					
Site ID No:325					
Site Designation:LMA-152					
Repair Type: Erosion					
Rating:Area of Concern					
Field Date:7/28/2017					
Notes: acess very difficult, steep slope, dense brush

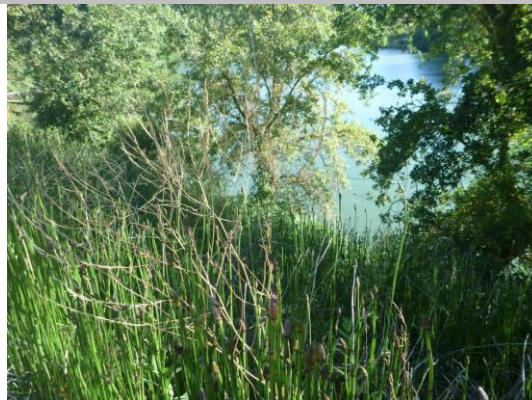
Photo 2 of 2 : FA_2018_RD0349_205_42_20180925_00025.jpg

Comment Code					
Inspector Comment					
Levee Evaluation Comments					
Description:District Station 128+76 to 129+27, Sec. 13, T. 5 N. R. 3 E., M.D.M. Approximately 51 linear feet of erosion exists along the water side slope of Steamboat Slough (Unit 2). The erosion area commences approximately 3/4 of the way down the slope from the levee crown and extends to the waterside toe around existing trees. No rip rap is visible in this area.					
Site ID No:325					
Site Designation:LMA-152					
Repair Type: Erosion					
Rating:Area of Concern					
Field Date:7/28/2017					
Notes: access very difficult, steep slope, dense brush
